# Management of Traumatized Tooth with Cantilever Bridge

Rustiqah FM, Farahanny W. Management of Traumatized Tooth with Cantilever Bridge. Dentika Dental Journal 2024; 27(2): 131-138

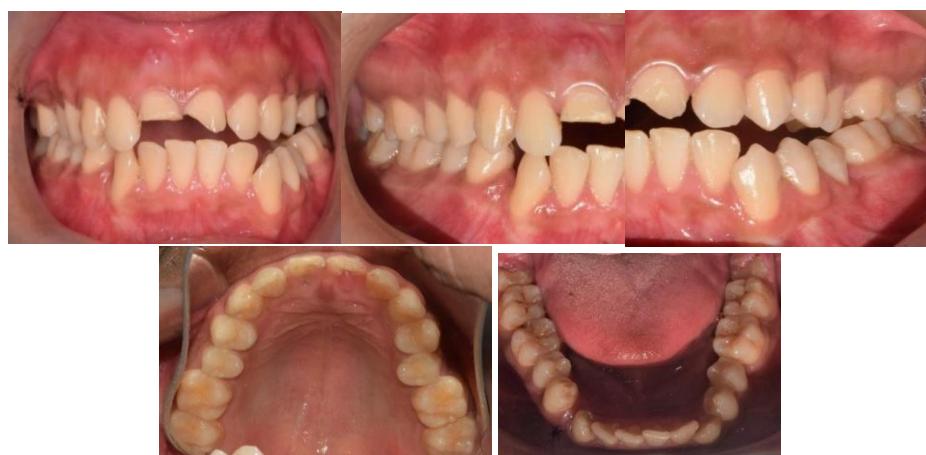
Figure 1. Clinical Examinations

A 22-year-old patient came to RSGM Universitas Sumatera Utara with a significant complaint of a fractured tooth that impaired appearance. Clinical and radiographic examination showed complicated crown and root fractures on anterior maxillary teeth (Figure 1). The diagnosis of the tooth was necrotic pulp with asymptomatic apical periodontitis (Figure 2. a, b, c, d). In addition, the treatment plan for tooth 11 was endodontic treatment. In contrast, tooth 21 was extracted due to a poor prognosis resulting from a horizontal root fracture in the middle third of the root, along with dislodgement of the fractured fragment, which was observed on CBCT. (Figure 2. c,d,e). A few weeks after tooth extraction, there was a resorption of alveolar bone in region 21. Aesthetic rehabilitation was restored using a cantilever bridge with artificial gingiva.

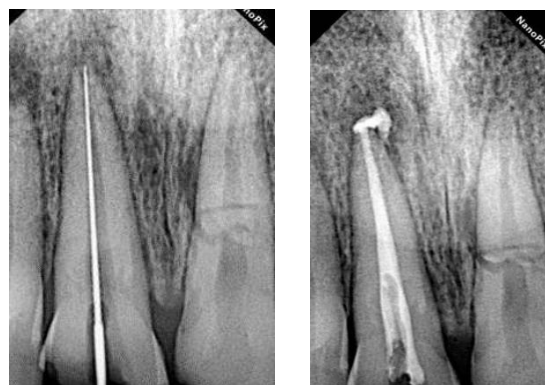
Figure 3. (a) Working length determination; (b) Calcium hydroxide medicament

In this study, there could be a loss of the front teeth as tooth 21 was to be extracted. The patient was concerned about the aesthetic factor and desired the natural color of teeth. In addition, the preferred treatment for tooth 11 was root canal therapy with lithium disilicate cantilever bridge and ovate pontic restorations. Detailed procedure was explained to the patient, and informed consent was obtained. On the first appointment, local infiltration was performed with an articaine of 2%, and isolation was carried out with a rubber dam. The access was established through an endo access bur. This study determined the working lengths using an electronic apex finder with a size #10 K-file and verified using radiography (Figure 3a). The root canal was prepared using the crown-down approach. Subsequently, the canals were cleaned and shaped using an E-flex blue file system. Each canal was prepared up to #25.06. Irrigation was performed with NaOCl 2.5% and saline between each instrument change and activated using an ultrasonic device. Paper points were used to dry out the canal, while calcium hydroxide was an intracanal medicament (Figure 3b).

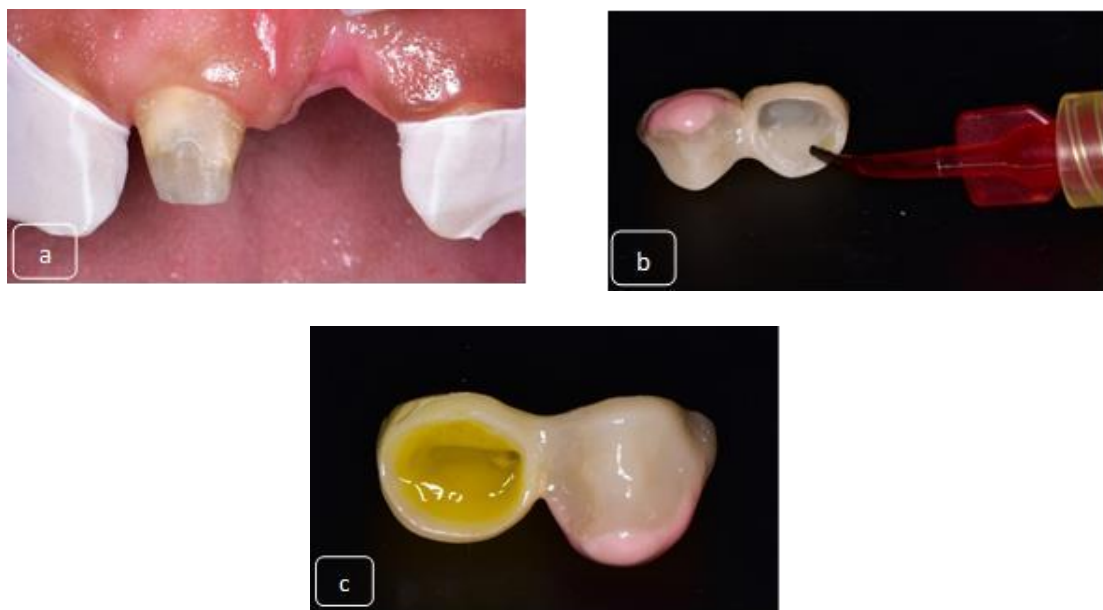
Figure 7. (a) Isolation politetrafluoroetilena; (b,c) 5% hydrofluoric acid

After 1 week, a lithium disilicate cantilever bridge was installed. After a try-in, color, contour, embrasure, edge density, occlusion, and proximal contact were examined. This case showed that tooth 11 was clinically examined again. The examination revealed that tooth 11 was asymptomatic, there was no response to percussion and pressure tests, and there was no wobble or abnormality in the surrounding periodontal tissues. A trial placement of the cantilever bridge was performed and examined for color, contour, edge density, adaptation to the preparation, proximal contact, and occlusion endings. Before cementation, the tooth was isolated with politetrafluoroetilane (PTFE) (Figure 8a). The inside of lithium disilicate crown was applied 5% hydrofluoric acid for 60 seconds, washed under running water, and dried. After that, silane was applied for 90 seconds and sprayed with air. Cementation was carried out using dual-cure resin cement (RelyXTM Ultimate, 3M ESPE, USA) (Figure 8 b,c).
