# Study of Pedestrian Path Comfort Evaluation in Campus Environment of Institut Teknologi Sumatera

Pedestrian paths serve as crucial arteries within university campuses, facilitating the movement of students, faculty, and staff. However, suboptimal pedestrian path conditions can hinder comfort, safety, and overall well-being, potentially discouraging walking and promoting motorized vehicle usage. This study delves into the evaluation of pedestrian path comfort and safety at the ITERA campus, employing a mixed-methods approach that encompasses direct observation and interviews with campus users. Findings reveal that the current state of ITERA's pedestrian paths falls short of providing an optimal environment for pedestrians. While the arrangement of trees contributes to a sense of security, the absence of pavement material and insufficient shade-providing vegetation detract from the overall pedestrian experience. Moreover, the lack of seating and road crossing markers further diminishes comfort. Zone C, in particular, stands out as a problematic area due to high pedestrian traffic. Respondents' perspectives reinforce the importance of both physical and atmospheric factors in shapin

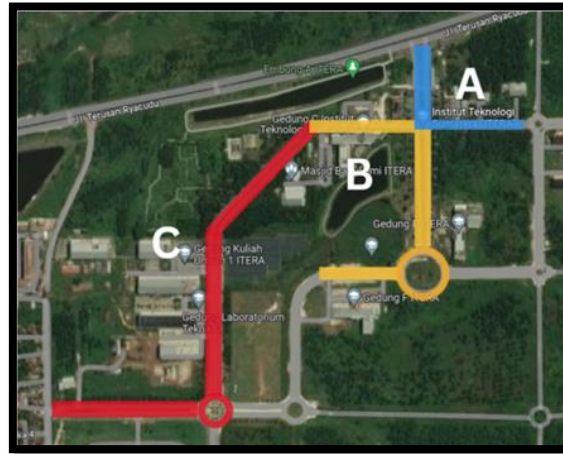
**Figure 2** Pedestrian path zone map

I Institut Teknologi Sumatera campus is equipped with pedestrian pathways that facilitate the integration of various campus activities. Consequently, specific areas within the campus have been selected for comprehensive analysis. Figure 2 offers a visual representation of these zones. This study encompasses three distinct areas: Zone A encompasses the main gate, Building A, Building B, the gallery, the BKL canteen, and the dormitory. Zone B includes Buildings C and D, the road intersection, Building E, the public lecture hall 2, the road roundabout, and Building F. Zone C comprises the basketball court, the RK canteen, the public lecture hall 1, the Engineering Laboratory 2, the Engineering Laboratory 5, the OZT laboratory, the road roundabout, and the west gate.

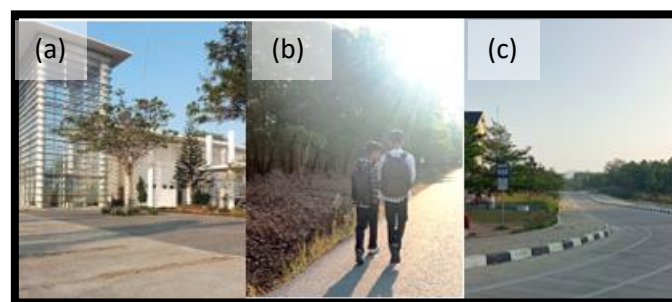
As illustrated in Figure 3, the pedestrian pathways in Zone A remain disparate and disorganized. Figure 4(a), illustrates that the walkway surrounding the main entrance is constructed with concrete, a material that is both practical and conducive to pedestrian traffic. Furthermore, the pedestrian path surrounding the main entrance is unobstructed, functioning not only as the primary thoroughfare for pedestrians but also as a gathering point for students. Furthermore, as illustrated in Figure 3(b), the absence of a designated pedestrian path on campus forces pedestrians to traverse the main road shoulder, which is also utilized by motorized vehicles. Consequently, pedestrians are compelled to utilize the highway to reach their intended destination. Figure 4(c), illustrates that the pathway situated in front of the dormitory is commendable, as it is furnished with a sidewalk constructed of paving blocks. However, the absence of vegetation surrounding the sidewalk gives rise to the sensation of heat when traversing it.

**Figure 3** (a) Pedestrian path near the campus entrance (b) Pedestrian path to the BKL cafeteria (c) Pedestrian path in the dormitory area

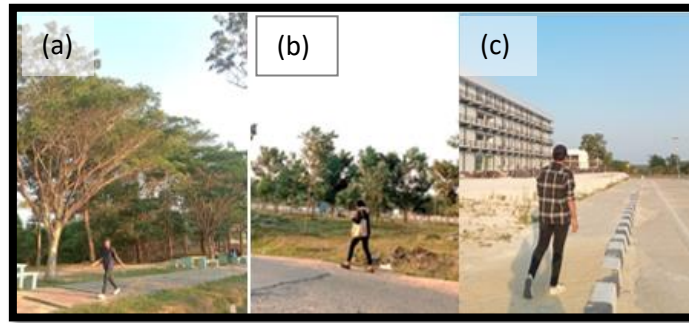
As illustrated in Figure 4(a), the pedestrian path in Zone B is observed to be in a satisfactory condition, offering a relatively comfortable and unobstructed passage. The materials utilized in the construction of the pedestrian path within this zone are concrete and paving blocks. However, the concrete surface of the pedestrian path is in poor condition due to its rough texture, which causes significant friction when walking. This area also features supporting vegetation and seating areas along the pedestrian path, providing additional temporary resting points. In zone B, as illustrated in Figure 4(b), there is no designated pedestrian path, and thus pedestrians utilize the highway as a walking area. Figure 4(c) depicts the condition of the pedestrian path that has been equipped with sidewalk facilities.

**Figure 4** (a) Pedestrian path in building area E (b) Pedestrian path in building area C (c) Pedestrian path in building area F

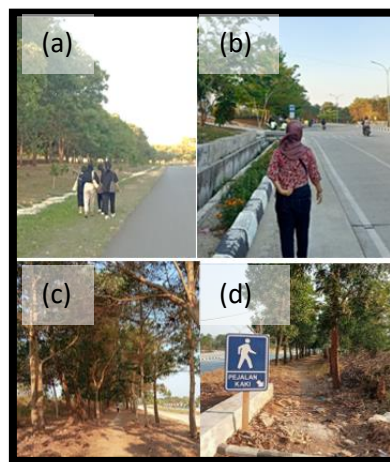
Figure 5(a) illustrates the conditions in zone C, which are less comfortable and less safe for pedestrians due to the absence of a sidewalk along the route connecting the C & D Building to the engineering laboratory building. This lack of infrastructure makes pedestrians feel unsafe, as they are at risk of being hit by motorized vehicles. Figure 5(b) illustrates the condition of the pedestrian path in the area in front of the OZT building, Engineering Laboratories 1 & 2, and GKU 1. The pedestrian path is constructed with paving material. Additionally, Figure 5(c) depicts a pedestrian path situated adjacent to the west gate of Zone C. This path is characterized by abundant vegetation, which provides a cooling effect when traversing it. Figure 5(d) illustrates a unique signage system designated for this pedestrian path. However, the path's condition is less than optimal, lacking a defined surface and proper maintenance. Consequently, during precipitation events, the lack of a paved surface and the presence of mud and slippery conditions pose a significant hazard to users.

**Figure 5** (a) Pedestrian path to the engineering laboratory building (b) pedestrian path in front of the OZT laboratory building (c) pedestrian path at the west gate (d) pedestrian path conditions that do not yet have pavement material

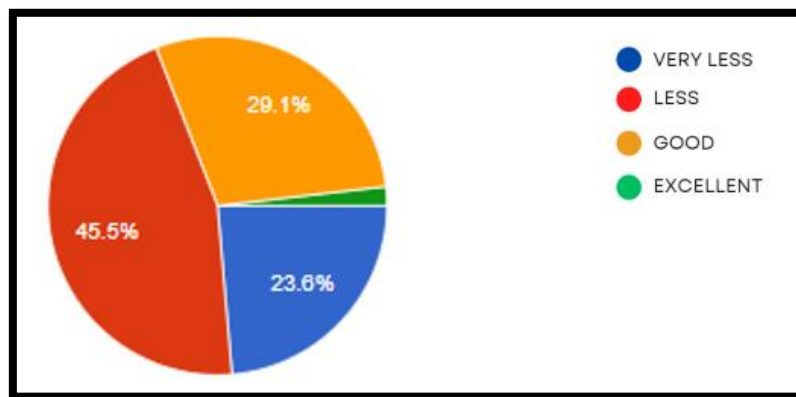
**Figure 6** Diagram of respondents' assessment of the current condition of pedestrian paths

Based on the data shown in Figure 6, it can be explained that as many as 45.5% and 29.6% of respondents answered that the pedestrian path at ITERA was in a very bad condition when viewed and used by pedestrians. And as many as 29.1% of respondents said that the condition of the pedestrian path was good because in some parts of the zone there were pedestrian paths whose shape and atmosphere were quite adequate. 1.8% of respondents thought that the pedestrian path was very good. Based on the results of the respondents' evaluation, it can be seen that the condition of the pedestrian zone is still not good and needs to be improved.

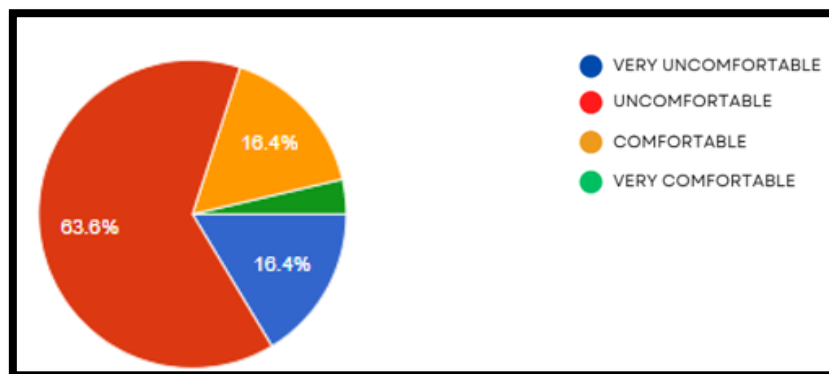
**Figure 7** Diagram of respondents' assessment of walkway comfort

Based on the data shown in Figure 7, it can be explained that the comfort when going through the pedestrian path at ITERA is 63% of respondents answered less comfortable. Even as many as 16.4% of respondents answered very uncomfortable because many pedestrian path facilities at ITERA were inadequate so that the level of comfort was very bad for its users. A positive assessment of respondents who stated that the pedestrian path was comfortable at 16.4% and very comfortable at 3.6%. From the data above it can be concluded that the pedestrian path in ITERA have not met comfort standards based on user perceptions.

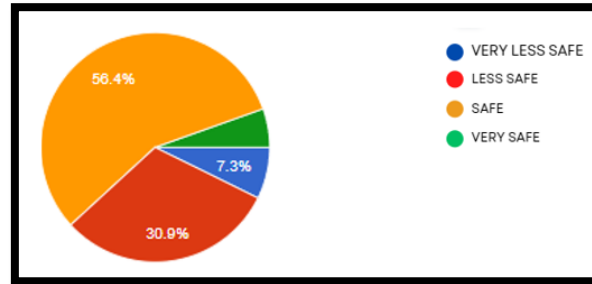
**Figure 8** Diagram of respondents' assessment of walkway safety

Based on the data shown in Figure 8, it can be explained that as many as 56.4% of respondents said the pedestrian path was still safe when passed and 30.9% of respondents said it was less safe because there were several pedestrian paths that did not exist so that pedestrians passed through the shoulder or roads that should not be passed by pedestrians. 7.3% said the pedestrian path while the remaining 5.4% of respondents said that the pedestrian path was very safe. from the data obtained shows that the pedestrian path has fulfilled user safety but needs to be improved especially in areas where there are no pedestrian facilities.

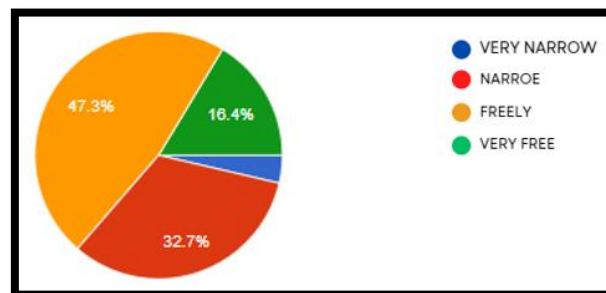
**Figure 9** Diagram of respondents' assessment of walkway circulation

Based on the data shown in Figure 9, it can be explained that as many as 47.3% of respondents said that the pedestrian circulation was quite free when passed by pedestrians. However, as many as 32.7% of respondents said that the pedestrian circulation was still narrow so that it was less free while passing through the existing path, as many as 16.4% of respondents stated that the pedestrian circulation was very wide because there was still a lot of empty land on the side of the road shoulder that could be used for walking. while the remaining 3.6% of respondents said that the circulation was very narrow. from the data obtained it can be said that the circulation of the pedestrian path is sufficient to accommodate users.

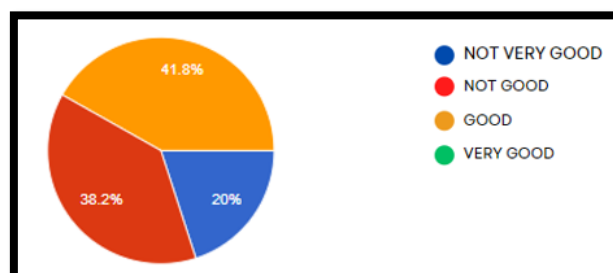
**Figure 10** Diagram of respondents' assessment of the condition of pedestrian path vegetation

Based on the data shown in Figure 10, it can be explained that 41.8% of respondents said that there was already vegetation in some areas of the pedestrian path so that it made the area shady. However, 38.2% of respondents said it was not good because the vegetation planted did not shade the pedestrian area so that it felt hot when passed during the day. 20% of respondents stated that the vegetation was very poor. based on the data above and in accordance with field data, it shows that the pedestrian path as a whole does not yet have shady vegetation considering that ITERA is a new campus so that the vegetation planted has not grown shady in all areas. it is necessary to arrange vegetation that is designed for pedestrians so that it not only becomes shady but becomes the aesthetics of the campus area.

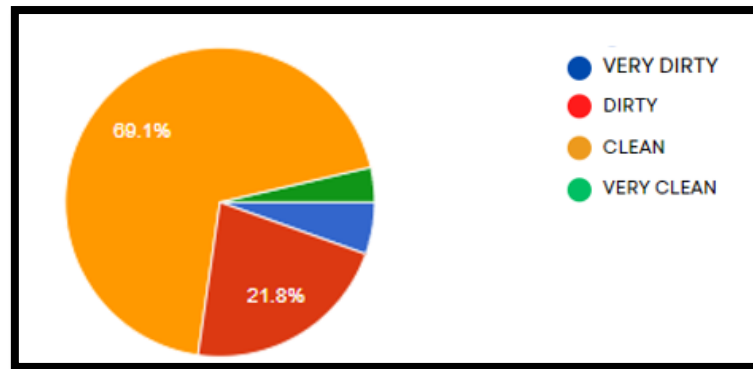
**Figure 11** Diagram of respondents' assessment of walkway cleanliness

Based on the data in Figure 11, it can be explained that the pedestrian paths are mostly clean and only about 21.8% of respondents stated that they are dirty because some paths still have dry leaves scattered because they are not reached by janitors or because the wind is strong so that the leaves of the vegetation fall off quickly. other respondents of 5.3% stated that the pedestrian paths were very dirty while the remaining 3.8% stated that they were very clean. Based on the data obtained and then adjusting the facts in the field, it can be concluded that the overall cleanliness condition of the pedestrian path is clean considering that there are janitors who routinely clean the pedestrian path, as for respondents who consider that the pedestrian path is still dirty, it shows that there are still some areas that are close to vegetation and there are many dry leaves falling.

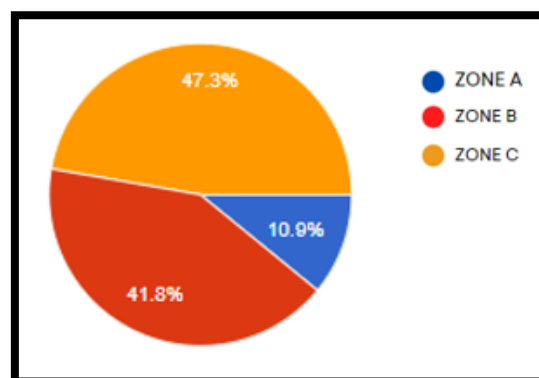
**Figure 12** Diagram of respondents' assessment of the overall condition of pedestrian paths in each zone

Overall, the road conditions described in Figure 12 show that, the assessment of Zone C which has the highest percentage of respondents, namely 47.3% of respondents, said that in this zone pedestrian users feel uncomfortable from the 7 aspects above and inadequate sidewalks. Then, the second uncomfortable pedestrian path is in Zone B as many as 41.8% of respondents answered in this zone because activities are often passed so that the comfort of shade vegetation is inadequate. And as many as 10.9 respondents said that in Zone A the pedestrian path has many adequate facilities, such as free space, sidewalks, and shade vegetation.

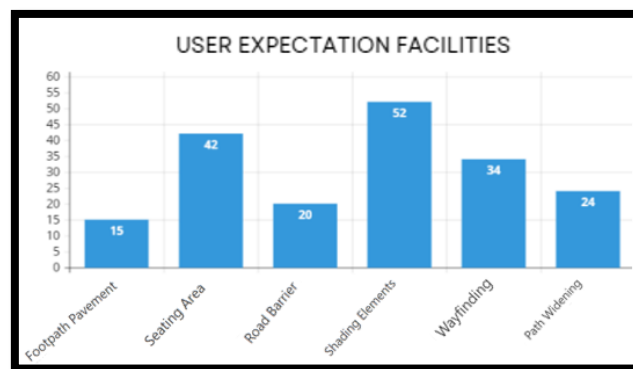
Figure 13 shows that 94.55% of respondents expressed their desire to have shade trees along the walkway to improve pedestrian comfort and reduce the heat of the sun during the day. This finding is in line with existing pedestrian walkway design principles, which emphasize the importance of vegetation in providing shade, reducing heat stress, and creating a more aesthetically pleasing environment. In addition, 76.36% of respondents requested seating facilities, such as park benches, for this purpose. The provision of seating along pedestrian paths is essential to enhancing comfort and relaxation among users, especially for those with limited mobility. In addition, 62.82% of respondents requested informative signage. Clear and well-placed signage plays an important role in guiding pedestrians, ensuring safety, and improving the overall user experience. The survey results further showed that 43.64% of respondents wanted wider pedestrian paths. Wider paths can accommodate increased pedestrian traffic, reduce congestion, and provide a more comfortable and inclusive environment for all users. In addition, 36.36% of respondents requested safety barriers that separate pedestrians from vehicular traffic. The implementation of physical barriers, such as curbs or bollards, is essential to protect pedestrians from vehicle hazards and ensure their safety. Finally, 27.27% of respondents requested paved pedestrian paths. Paved walkways offer a smooth, stable, and accessible walking surface, especially during inclement weather conditions.

**Figure 13** Diagram of respondents' assessment of expected pedestrian path conditions
